AERIAL PHOTOGRAPHIC ANALYSIS OF SELECTED HAZARDOUS WASTE STUDY SITES

New Mexico and Texas

EPA Region VI

TS-AMD-82110a
April 1983

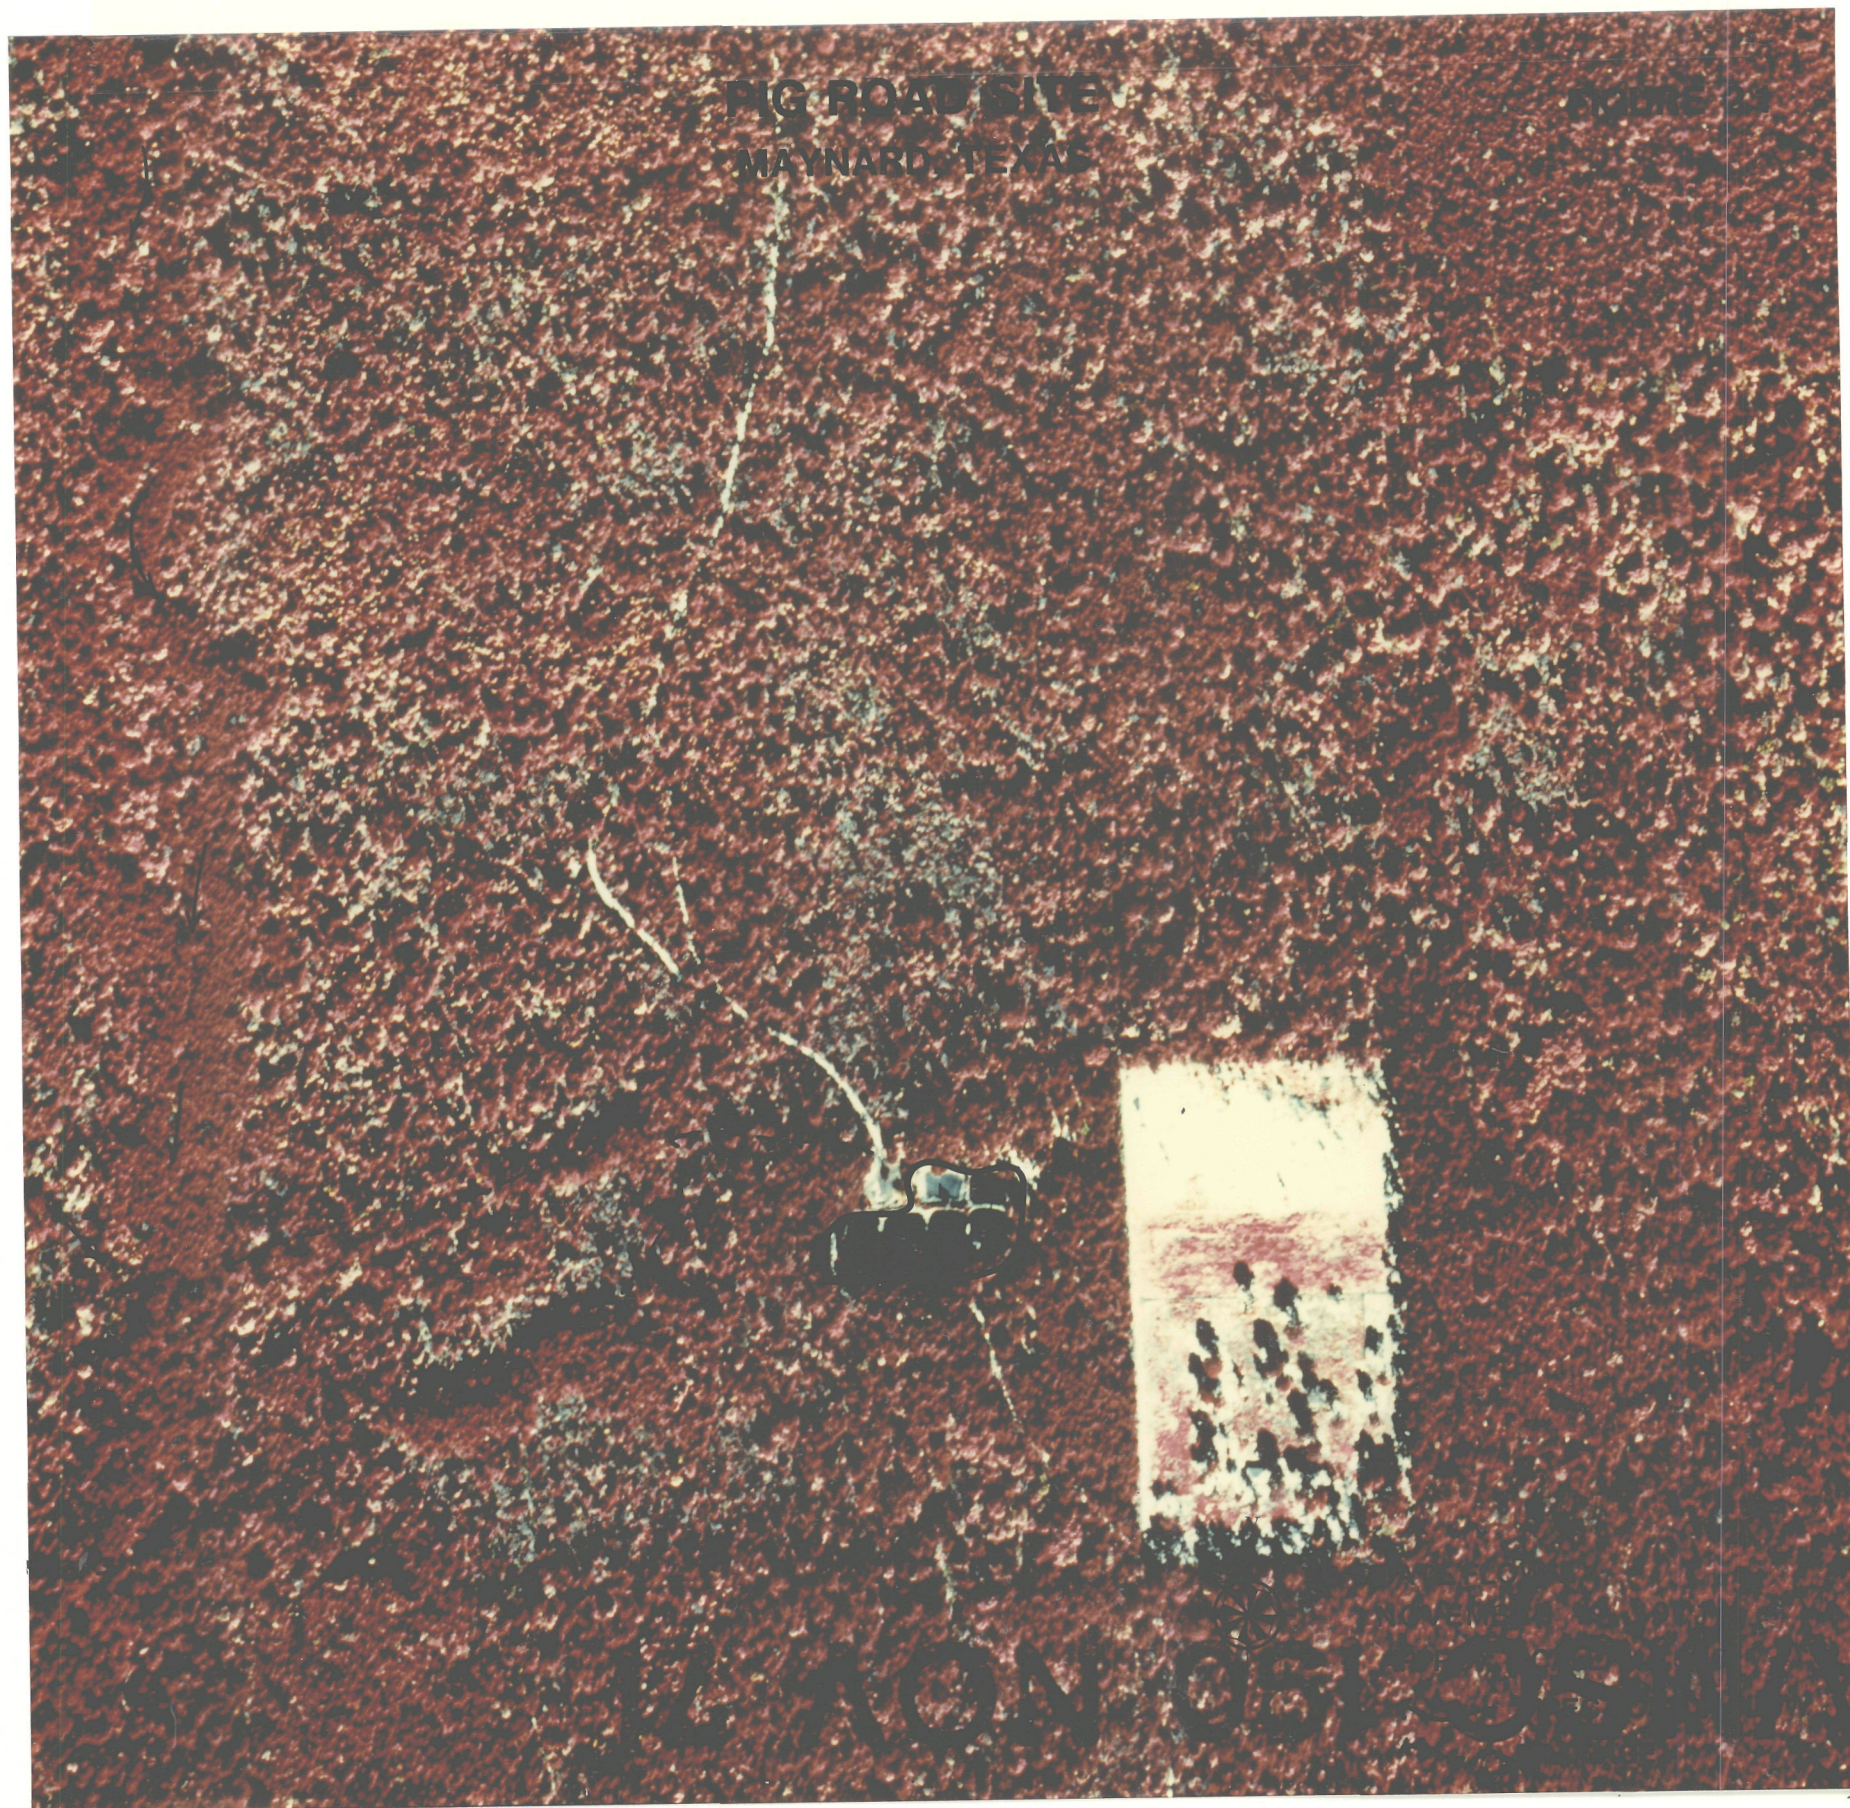
All of the waste ponds, with the exception of Pond 1, appear to be filled to capacity (Figure 21). Only a portion of the individual berms that separated the ponds remain visible. This suggests that the ponds have spilled over into one another. Overflow cannot be seen outside of the contained areas on the northern, western, or eastern sides of the site. Tree shadows mask the southern boundary of the site, and it cannot be determined whether overflow has entered the area south of the site.

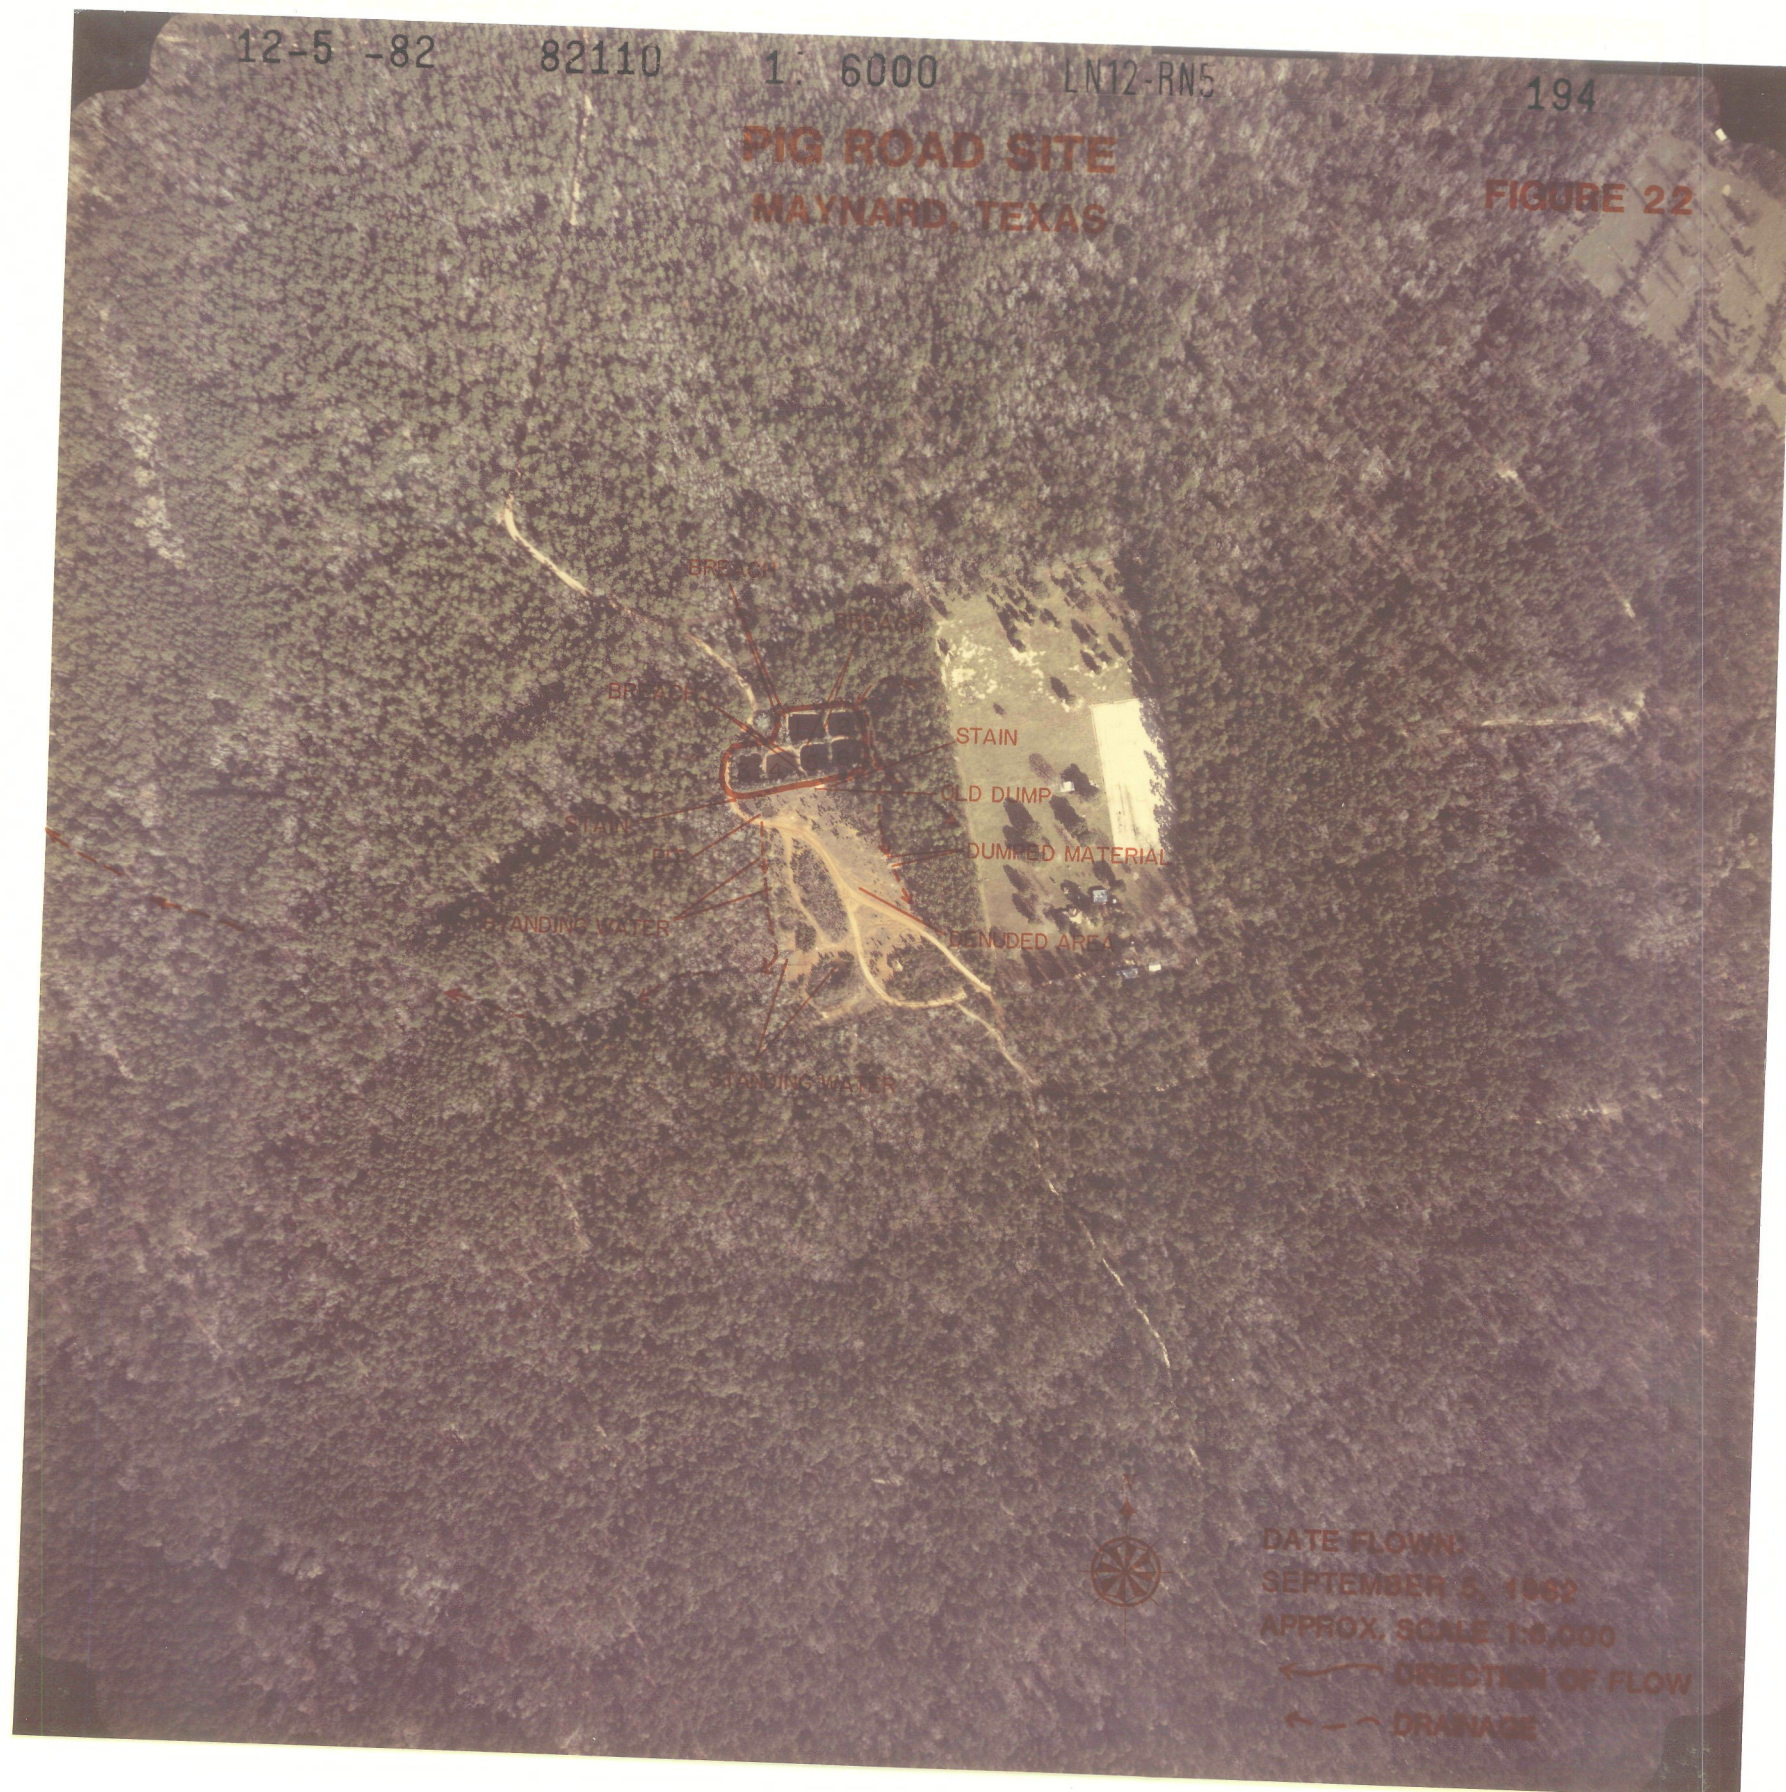
FIGURE 22

Breaches are visible within several berm walls (Figure 22). Waste liquids appear to be passing between ponds 1 and 2, and between ponds 4 and 5. There is no indication that liquid held within pond 1 has flowed out of two breaches that are present at the northwest corner of the pond. Stains are visible in two areas located outside the southern boundary of the waste ponds. It cannot be determined whether waste liquid has leached out of the ponds, resulting in the stains.

A large area located south of the waste ponds has been stripped of a good portion of its vegetative cover. A moisture-stained pit, an old dump, and two piles of an unidentified dumped material are present within the denuded area. Accumulations of what appears to be standing water are also noted.

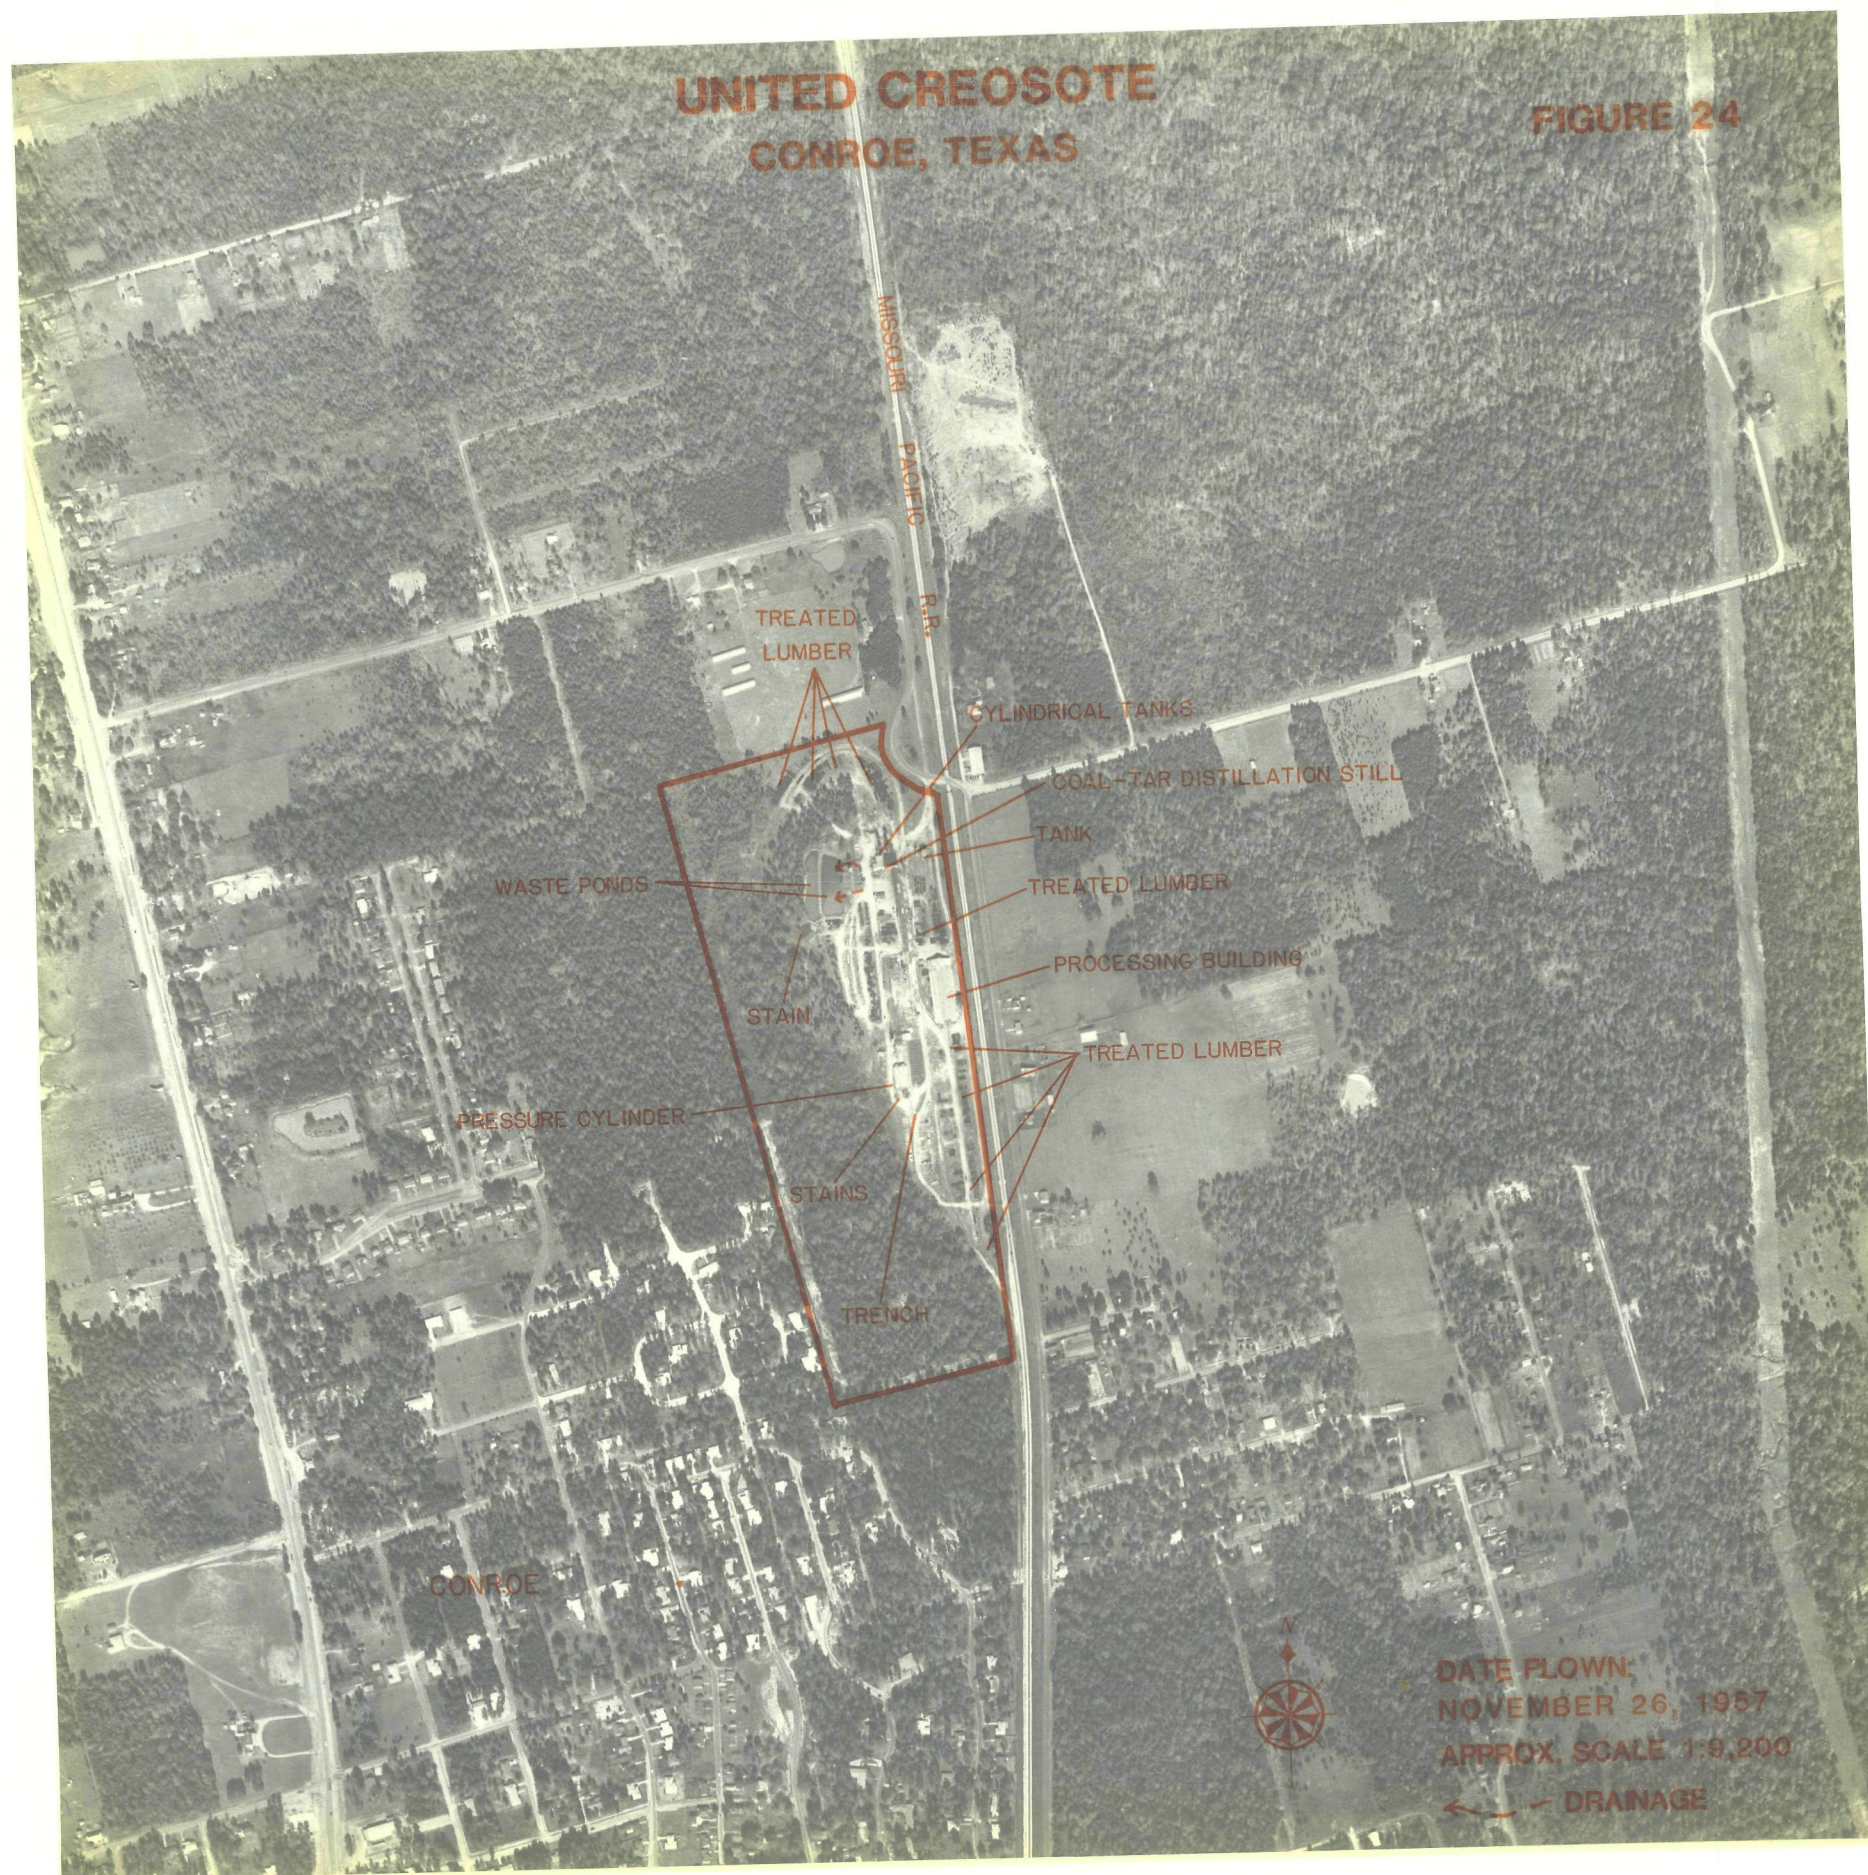
Several objects that appear to be cylindrical tanks are present at the northern end of the coal-tar distillation still. An uncontained storage tank is noted in the same vicinity. Liquid wastes are apparently disposed of within two ponds that are present within the northern section of the site. Stains are noted near the ponds and at the pressure cylinder. No drainages that could be threatened by spillages are apparent on this photograph.

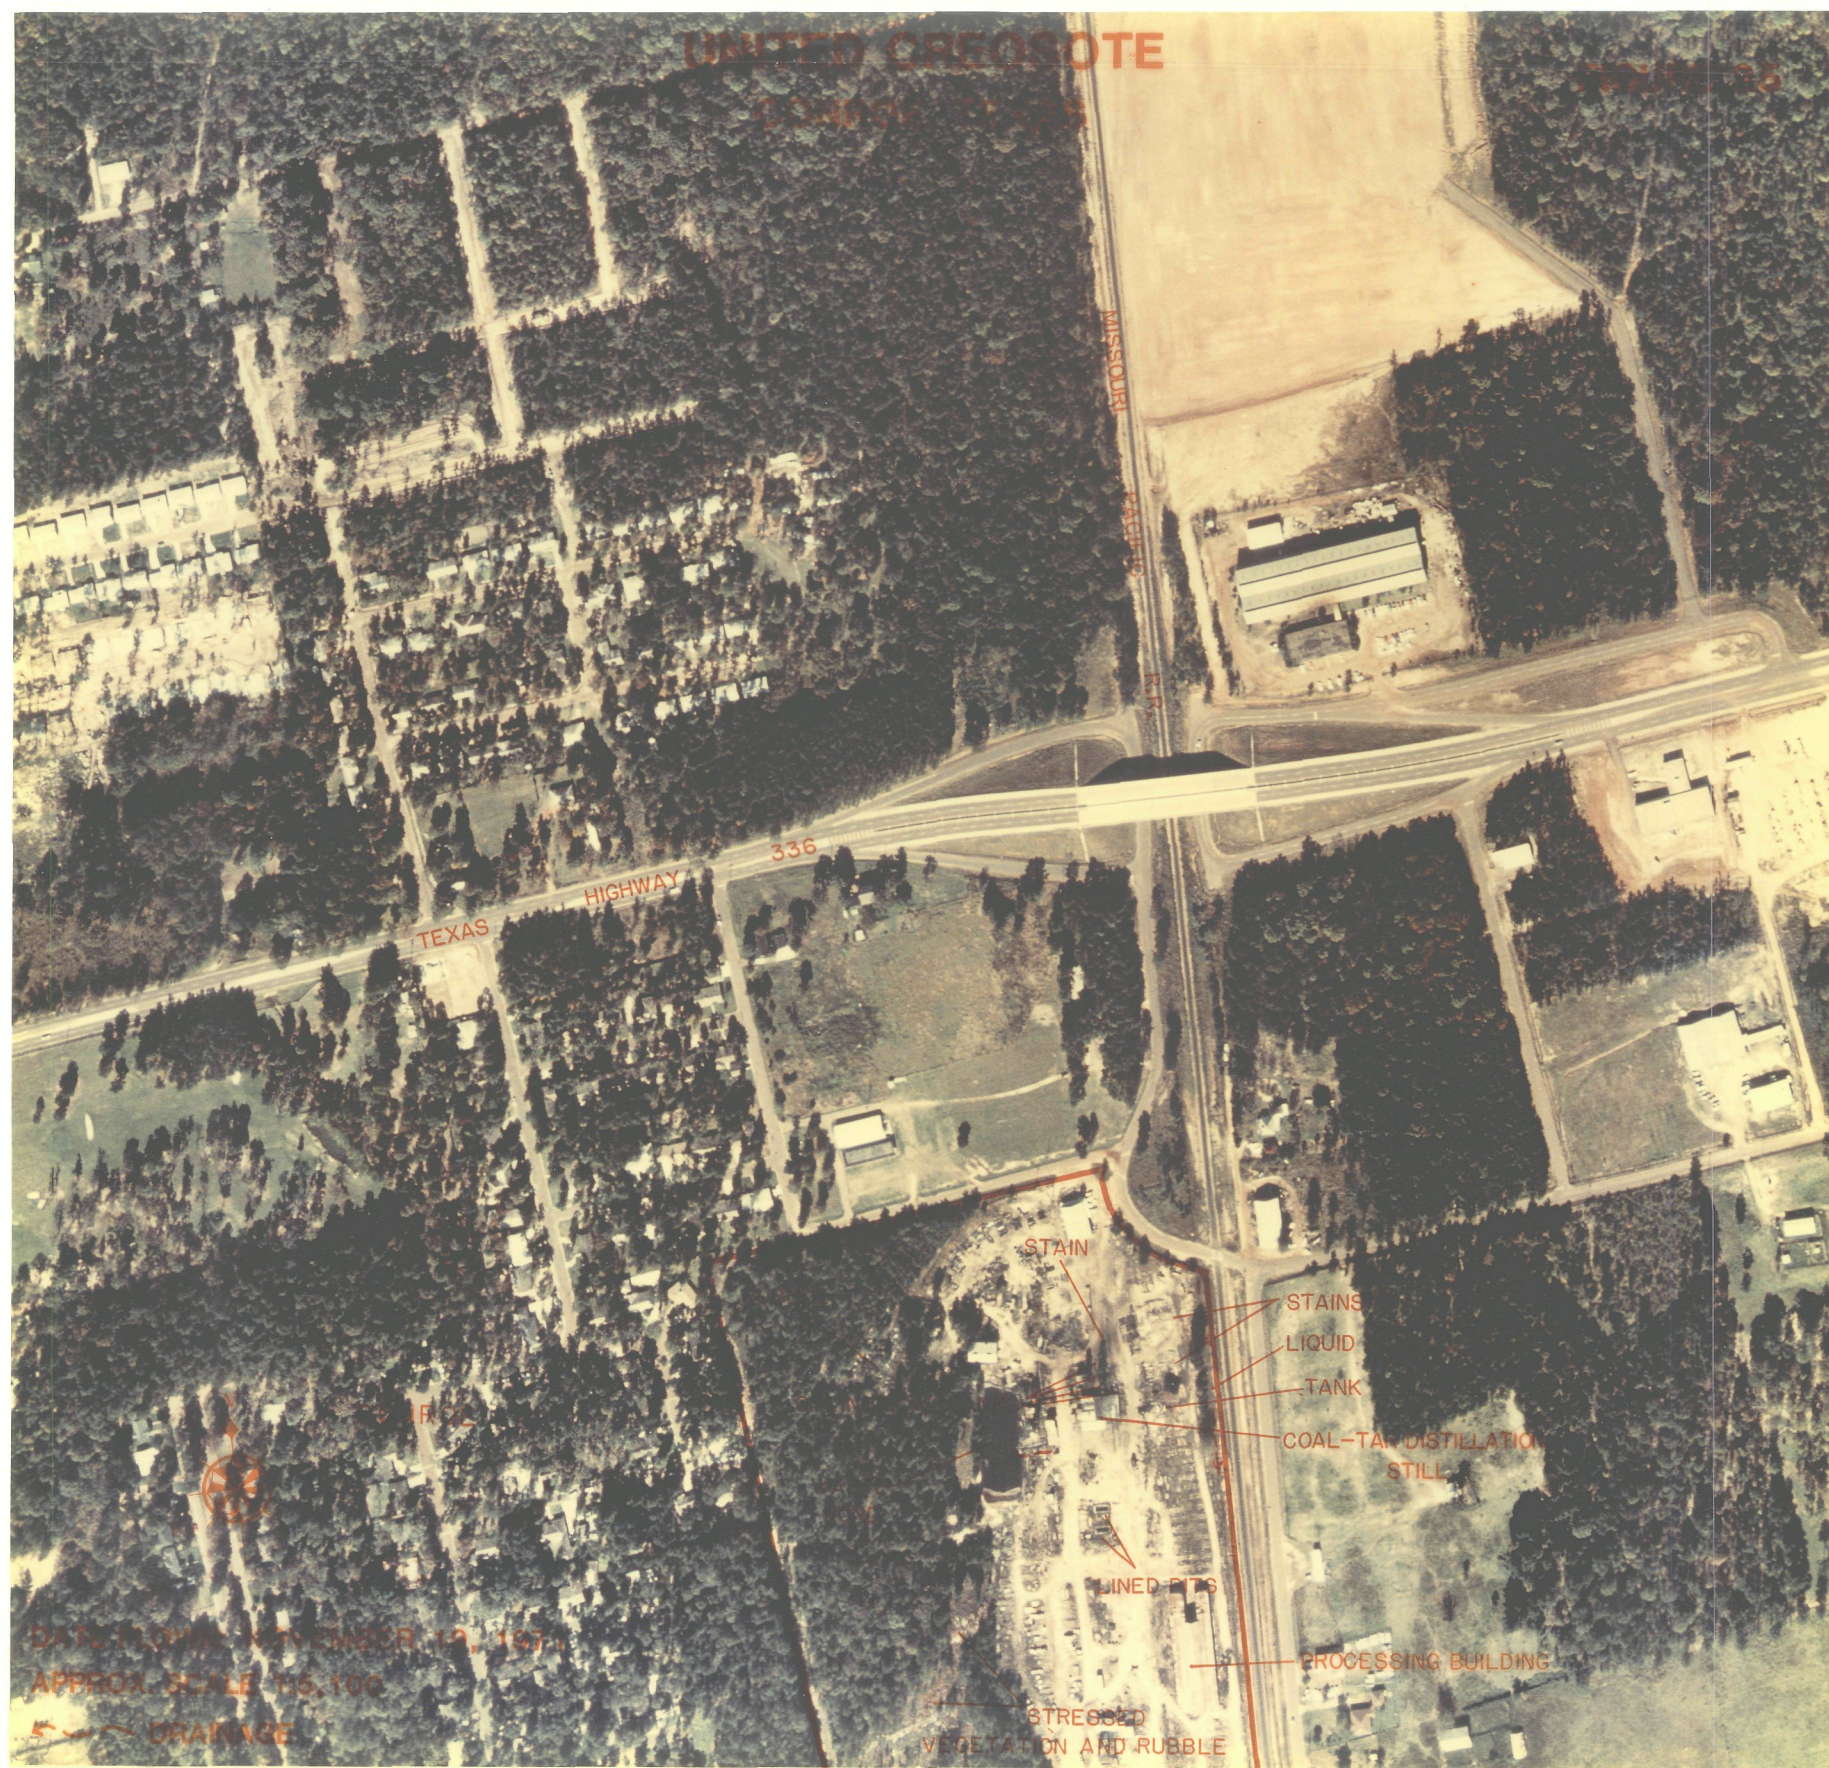
The northern half of the creosoting facility is visible on this photograph (Figure 25). A single waste pond is present where two were visible during November 1971. The berm which separated the two ponds has been removed or has been overflowed. Two waste pits that were not present on the November 1971 photograph (Figure 24) are visible on the current photograph. The pits appear to be concrete-lined, and are filled with an unidentified dark substance.

Stains are noted in the vicinity of a large tank that is located east of the coal-tar distillation building. Additional stains are noted near several tanks that are situated at the northern end of the same building. An accumulation of liquid has collected within a ditch located along the western side of the Missouri Pacific Railroad system. This accumulation may be fed by spillage from the uncontained tanks which are present within the site.

Rubble and/or other solid wastes have been dumped into two areas. The southernmost dumping area shows signs of considerable vegetative stress.

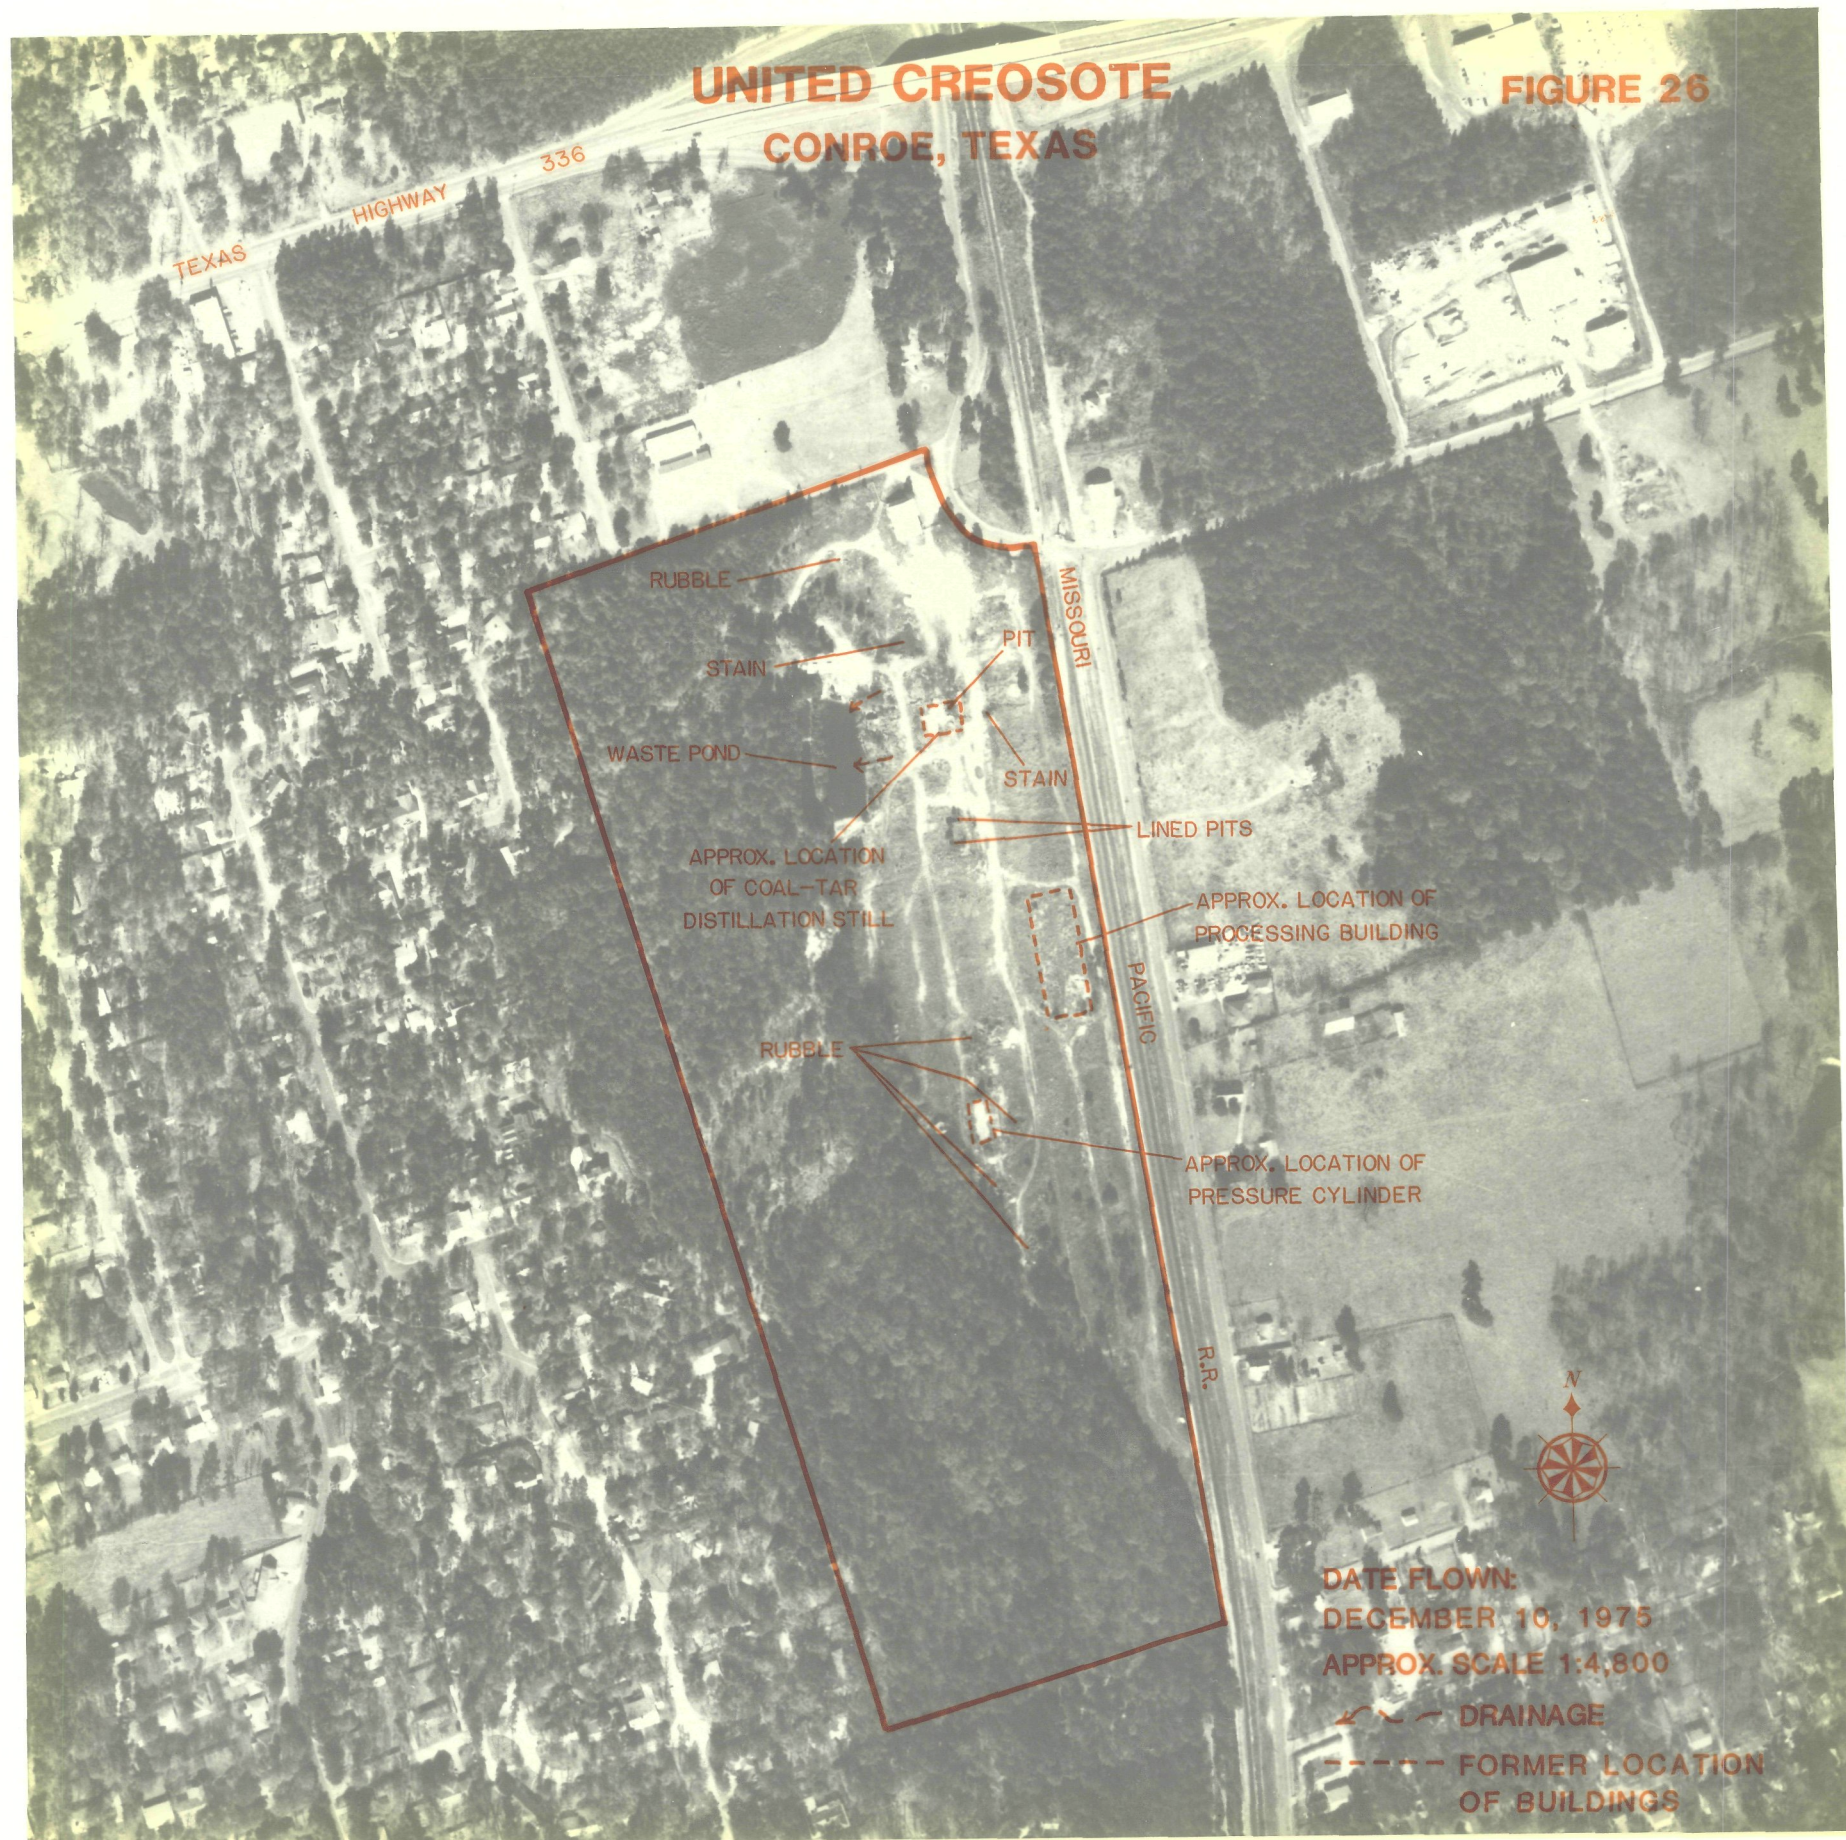
Most of the structures that were visible on the November 1957 and November 1971 photographs, Figures 24 and 25, have been removed (Figure 26). The waste pond and lined pits that were present on the 1971 photograph are still visible. A third pit is noted on the former site of the coal-tar distillation still. Piles of rubble and stains are also noted within the creosoting facility. The stains suggest the possibility of leachate or seepage from buried wastes that may be located on the site.

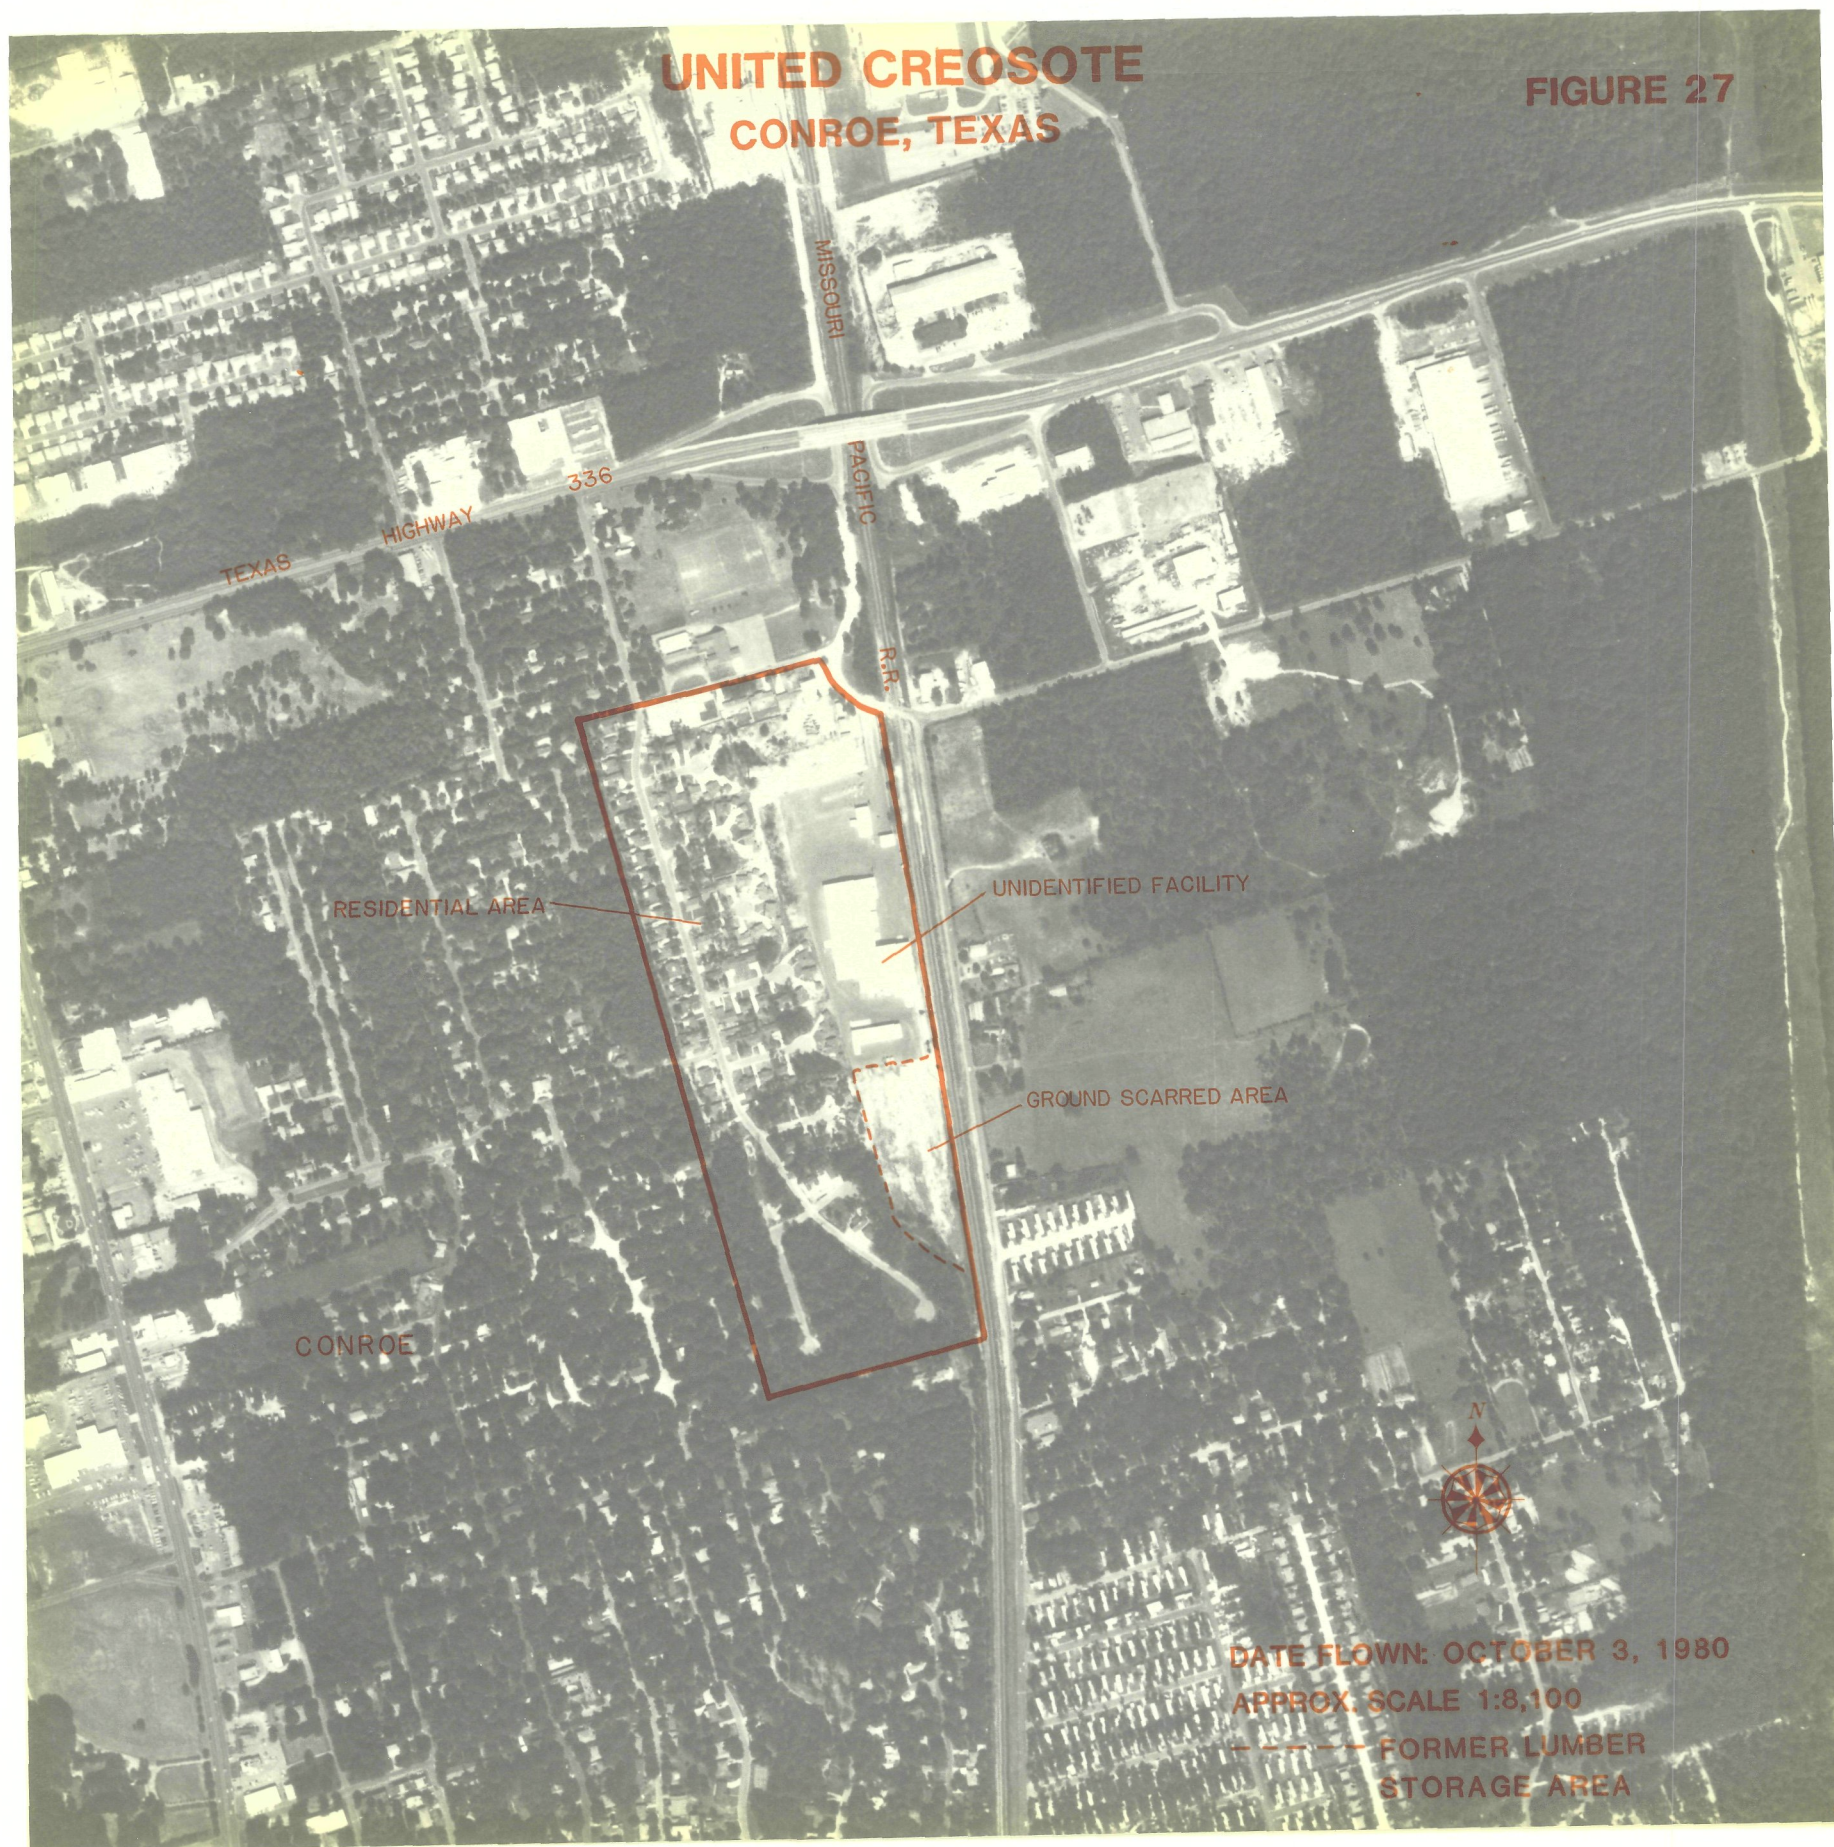
All structures that formerly were associated with the creosoting facility have been removed (Figure 27). An unidentified facility and a residential area have been constructed upon the former site of the creosoting facility. A heavily scarred area that was formerly used for the storage of treated lumber may be a disposal or storage area for the unidentified facility.
